BROWNFIELD REDEVELOPMENT ASSESSMENT REPORT

PACKARD PLANT COMPLEX

DETROIT, MICHIGAN

March 24, 1998

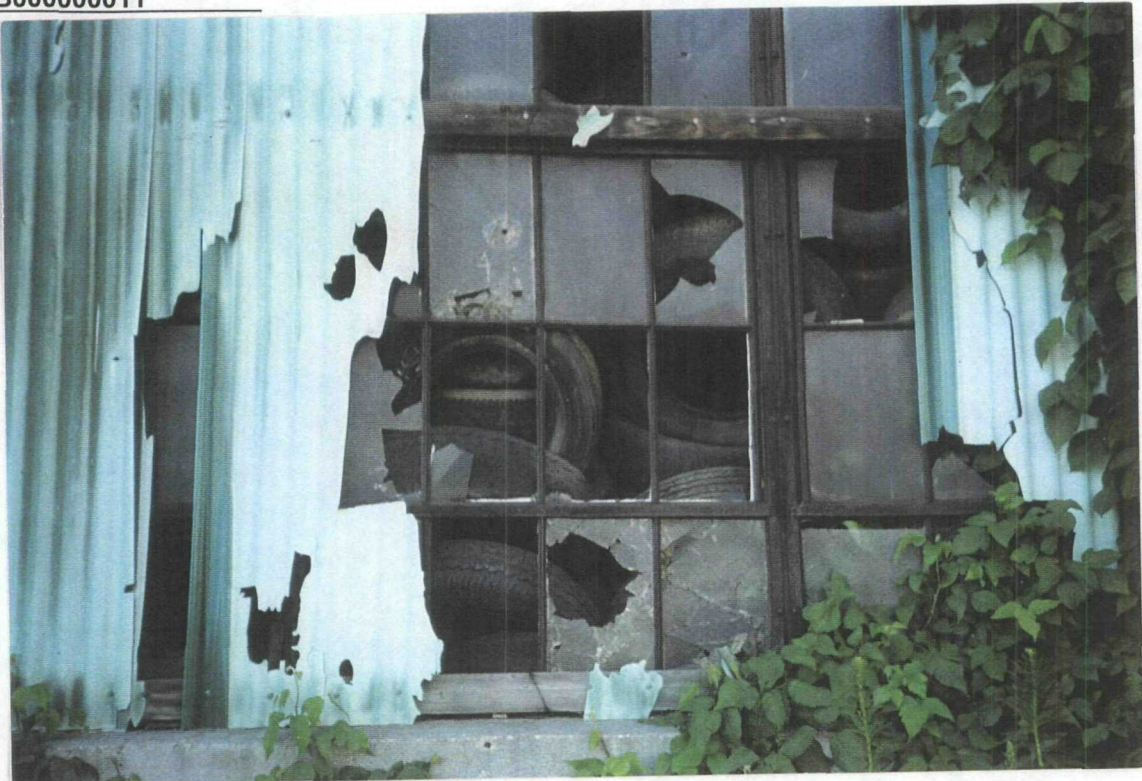
- Removal of approximately 500,000 used tires piled into the first floor at the south end of Building 38. Tires, present in such a large quantity, can be deemed a fire and environmental hazard. A second smaller amount of tires is located on the second floor of Building 92.

Portion of tires crammed into first floor room in Building 38; tires facing onto Bellevue Avenue.

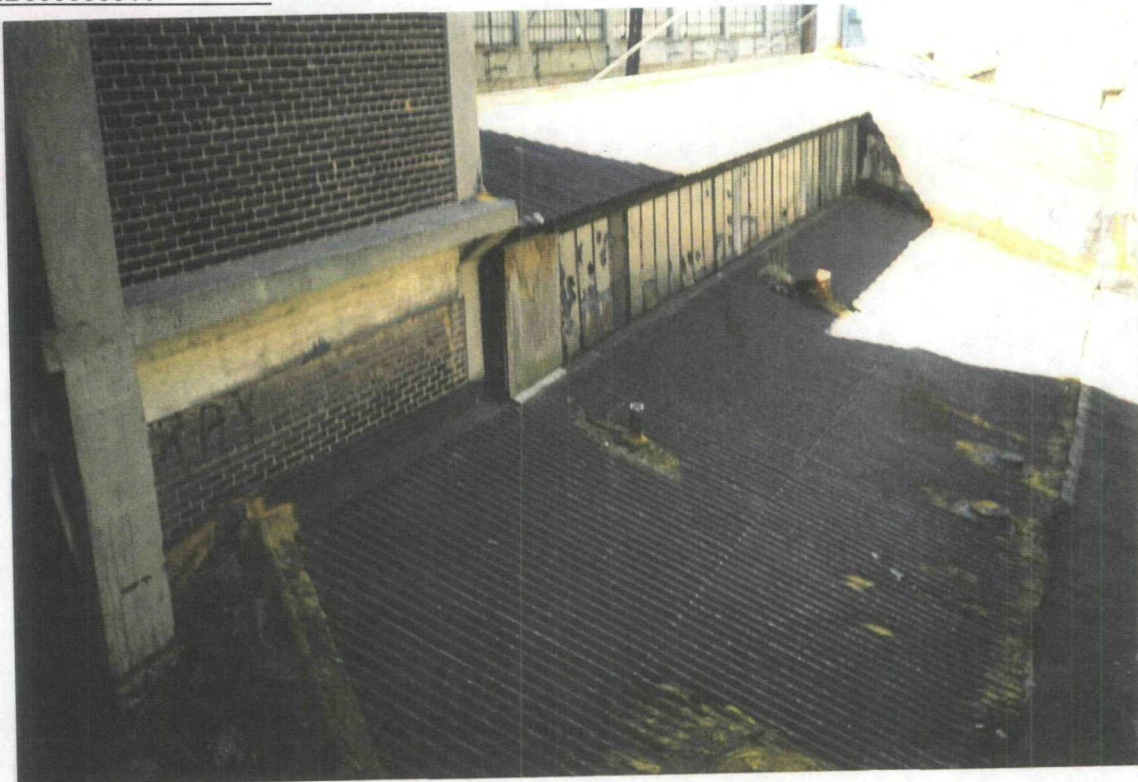
Lead vent pipe on roof of Building 34 as seen from third floor of Building 35.

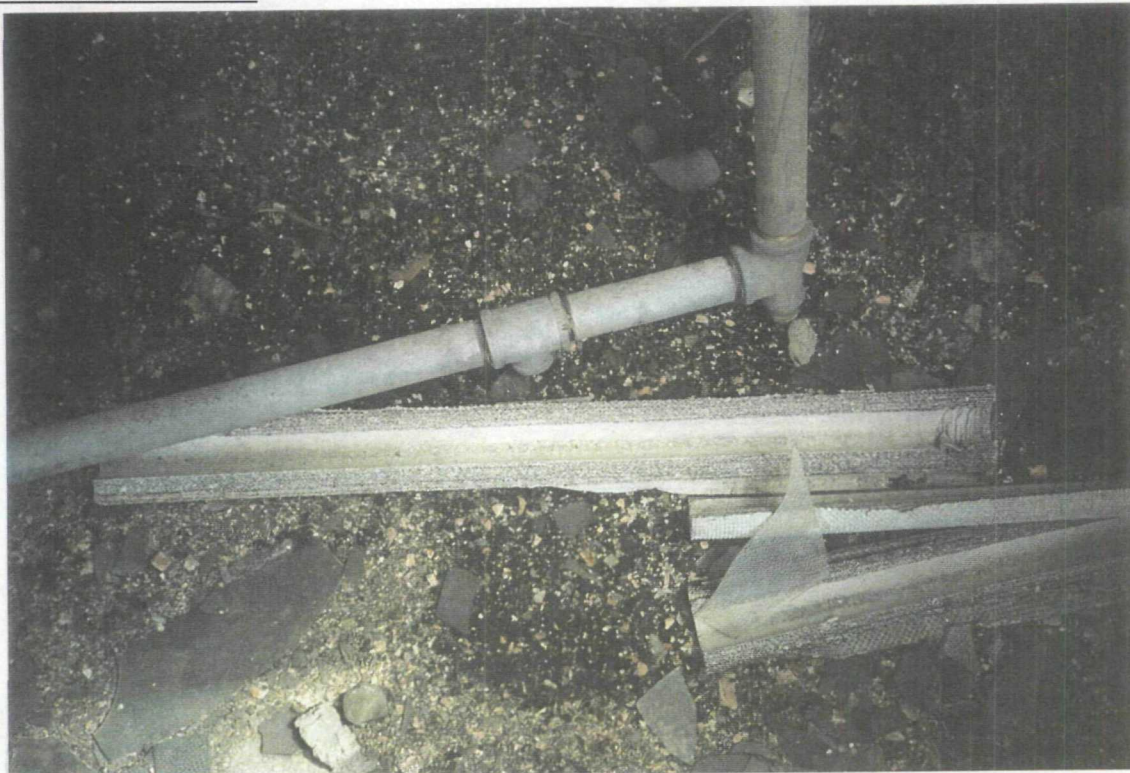
Asbestos pipewrap (aircell) near bathroom on third floor of Building 92, northeast corner of floor.

- Refuse and other material dumped around the exterior of Building 92.
- All regulated asbestos containing material (ACM) in the complex should either be removed from the buildings or encapsulated during any revitalization of the structures. Removal of ACM must follow National Emissions Standards for Hazardous Air Pollutants (NESHAP) guidelines. Asbestos observed in the tenant occupied areas of the complex (first floors of Buildings 2,4,4C,10,10C,15,15C, 17, 17C, 19, 19C, 21, 31 31C) were well maintained and pose little to no risk to the workers. Asbestos observed in the vandalized or vacant portions of the complex was torn and hanging from the pipes or scattered over the floors exposing the fibers and creating a risk of inhalation exposure.

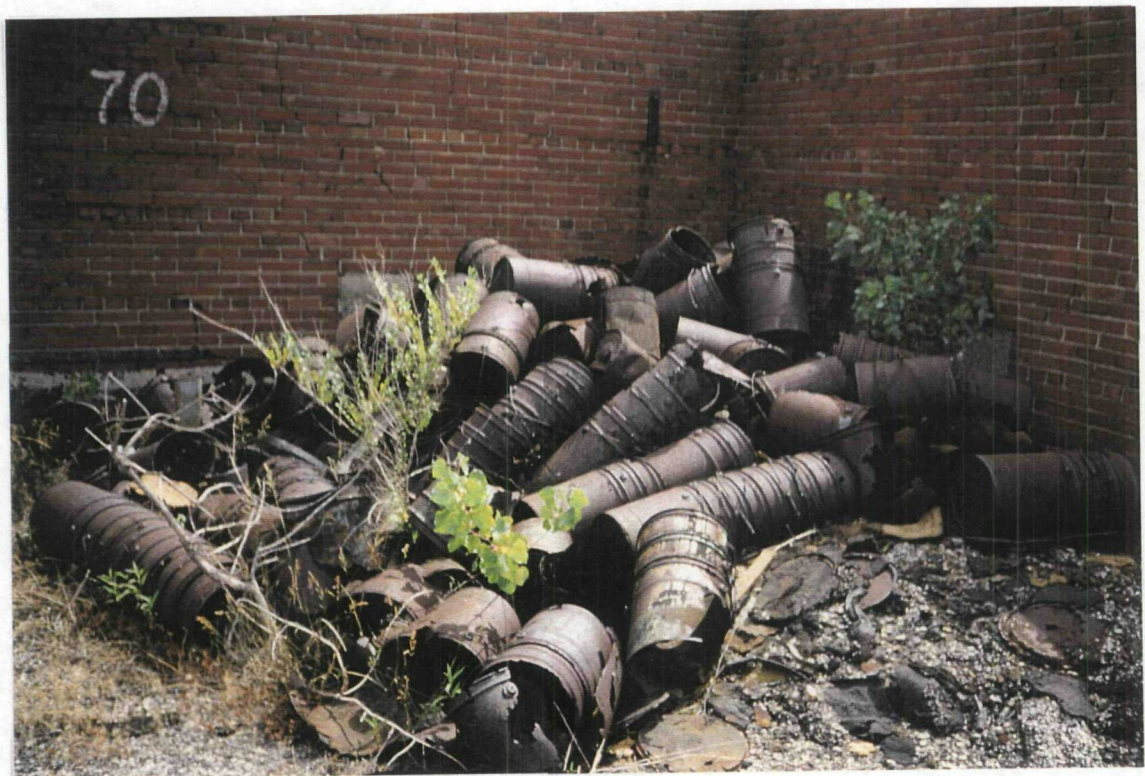
Roof Access to the roof is via the west stairwell. There are two large piles of 5-gallon, black metal buckets, one in the northeast corner and the second in the southeast corner. These buckets may have contained asphalt roofing material as numerous roof patches are located over the roof. The capacitor room at the top of the elevator shaft, which has been vandalized, contains spilled oil on the floor, one damaged capacitor carcasses and scattered capacitor fins.

DESCRIPTION:  
Piled 5 gallon containers at northeast corner on roof of Building 92. Assumed once held asphalt roof patch material.

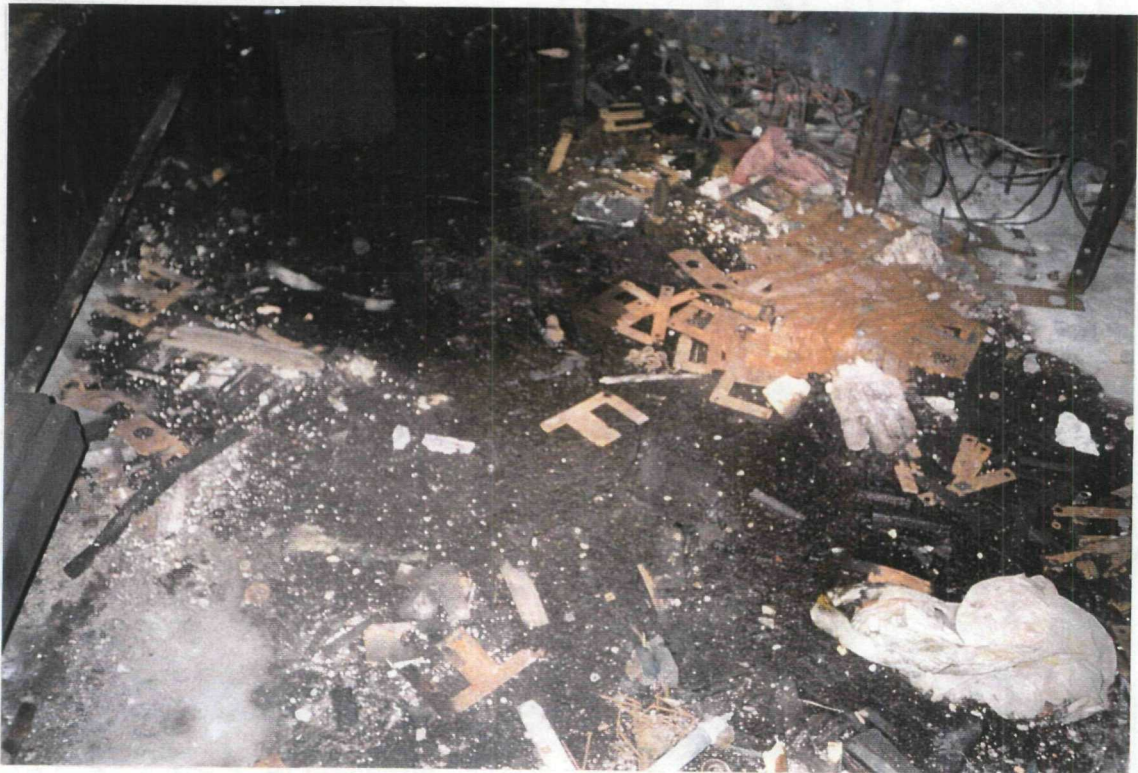
DESCRIPTION:  
Capacitor room at top of elevator shaft on Building 92; vandalized, oil stained floor, carcasses scattered about.

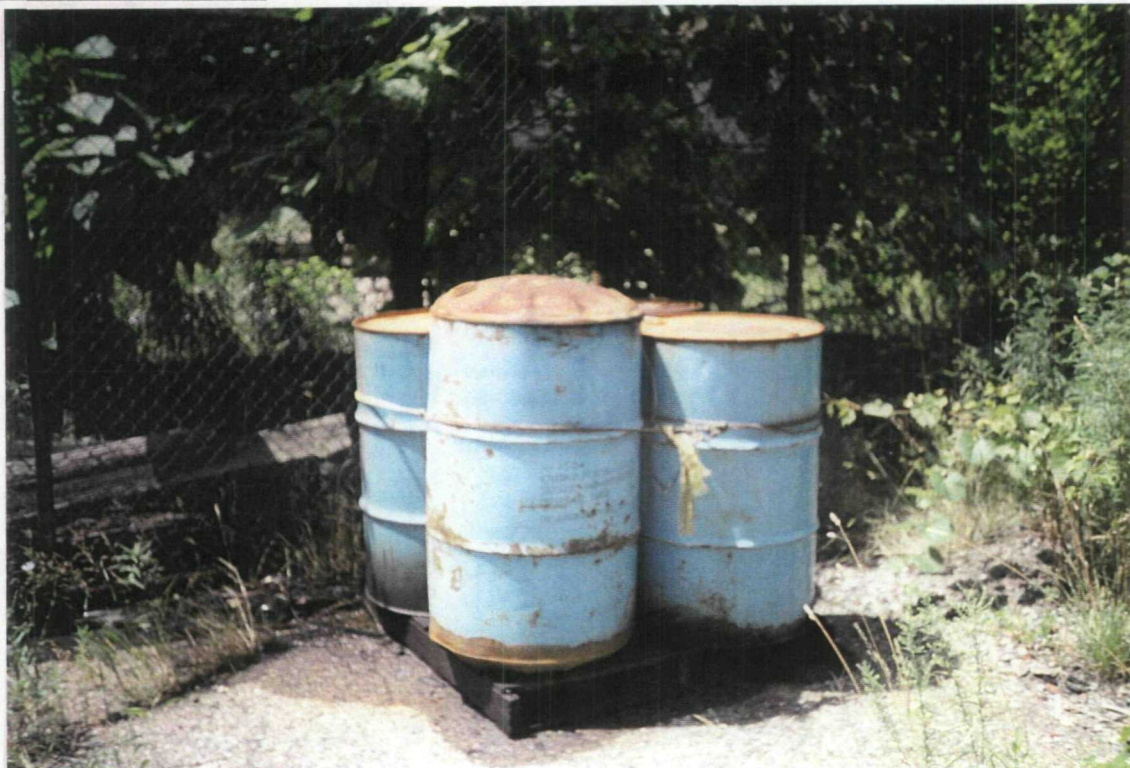
Four 55 gallon drums along west outer wall of Building 7/8/9; one or all suspected of leaking.

- Sampling of drum contents and removal of all drums and containers found throughout the complex, especially on the first floor of Building 23, the fifth floor of Building 18-16-11-12 and the fourth floor of Building 92.

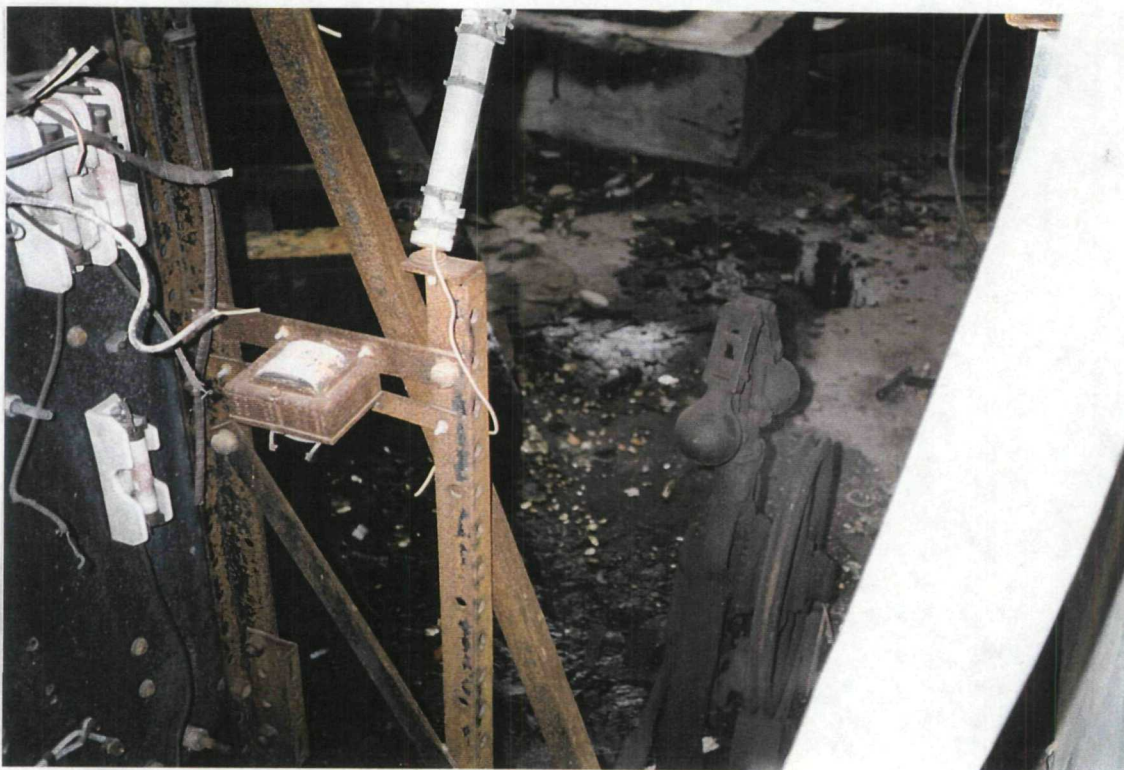
Capacitor room at top of elevator shaft on Building 92; vandalized, oil stained floor, carcasses scattered about.

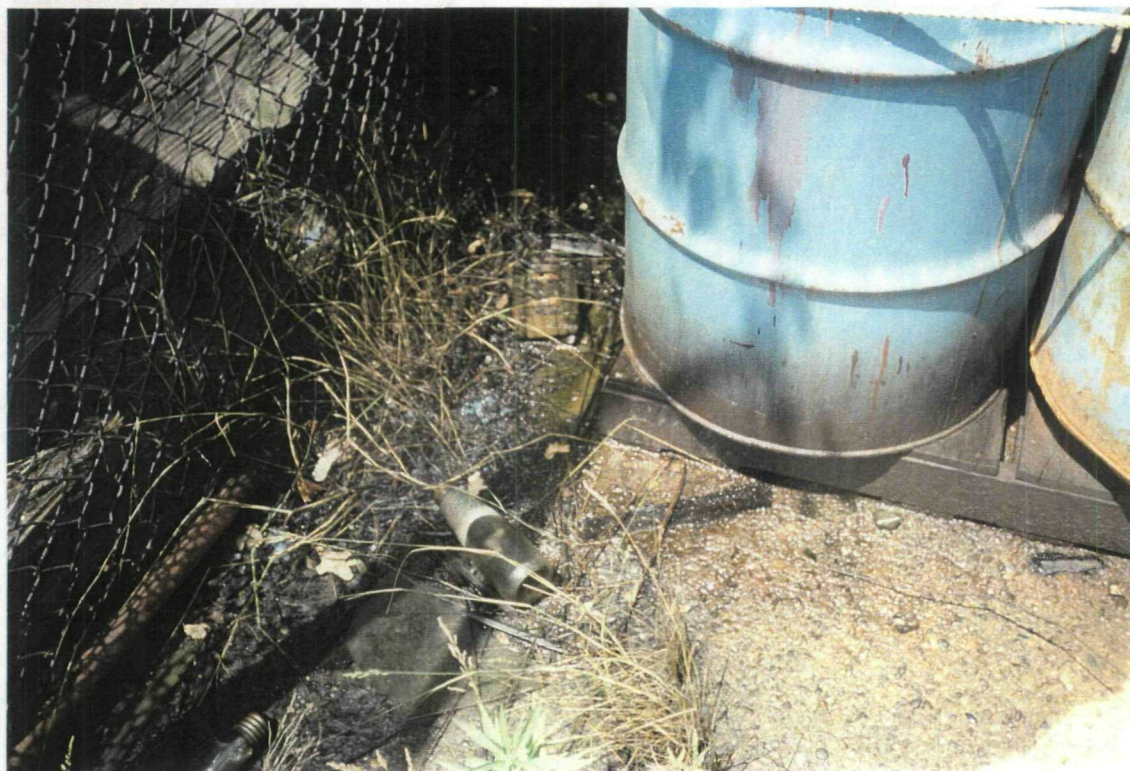
Four 55 gallon drums along west outer wall of Building 7/8/9; one or all suspected of leaking.

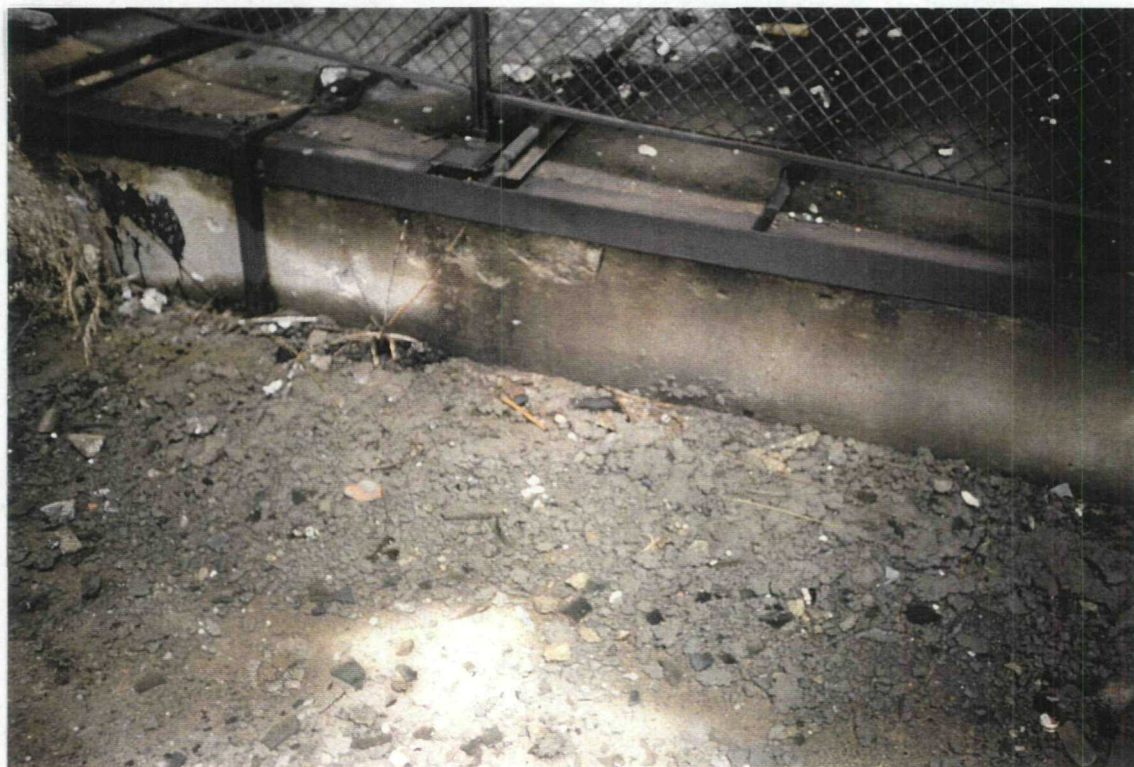
Area of three former transformers outside Building 7/8/9, stained soil and concrete pad.

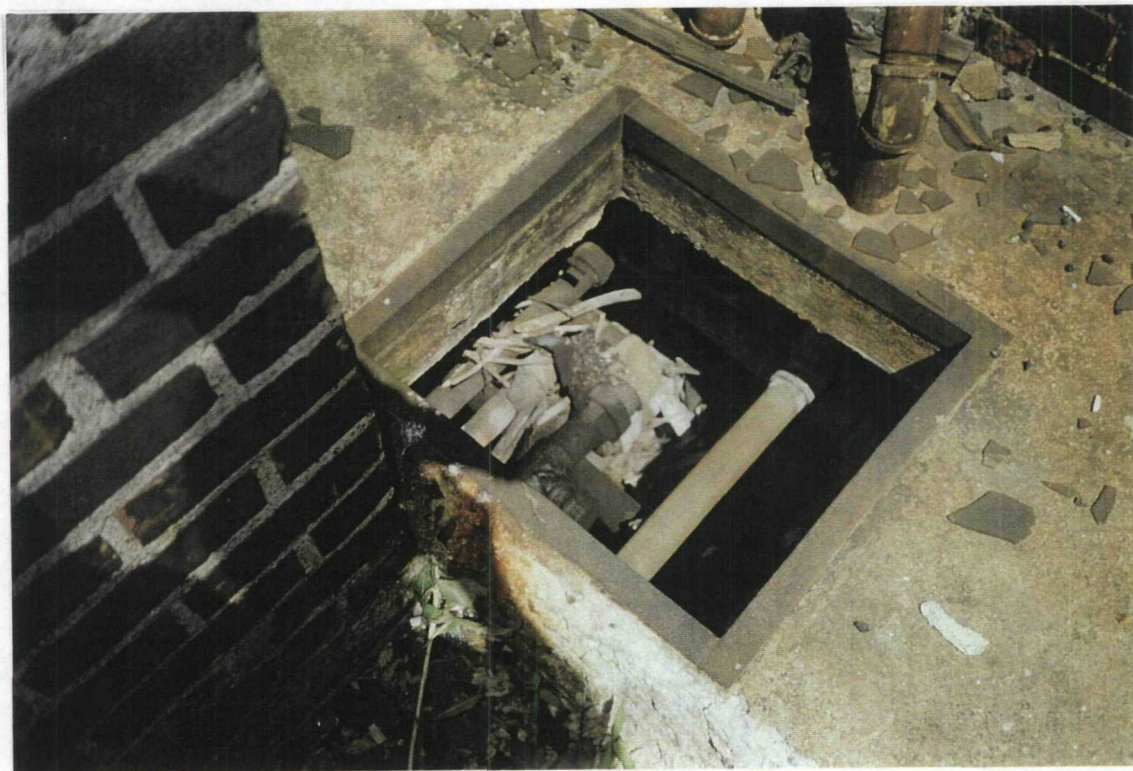
- Appropriate measures to control future worker exposure risks should be followed during any removal/remediation work undertaken at this facility.
- Bird droppings and carcasses were observed in numerous stairwells in the vacant portions of the complex buildings, in particular Buildings 1,5,9 and 92. Frequent exposure to bird droppings have been documented to be the cause of intestinal, lung or skin health problems in human beings.
- Further investigation of a suspected underground storage tank (UST) area in the north west portion of the complex outside Building 9. Stand up pipes from the concrete pad, a small brick pump house, pipe vents along the outer wall of Building 9 and flush mounted metallic manhole covers indicate the presence of one or more USTs under the concrete pad.

Underground piping system near pump house along outer west face of Building 9. Also suspected UST field.

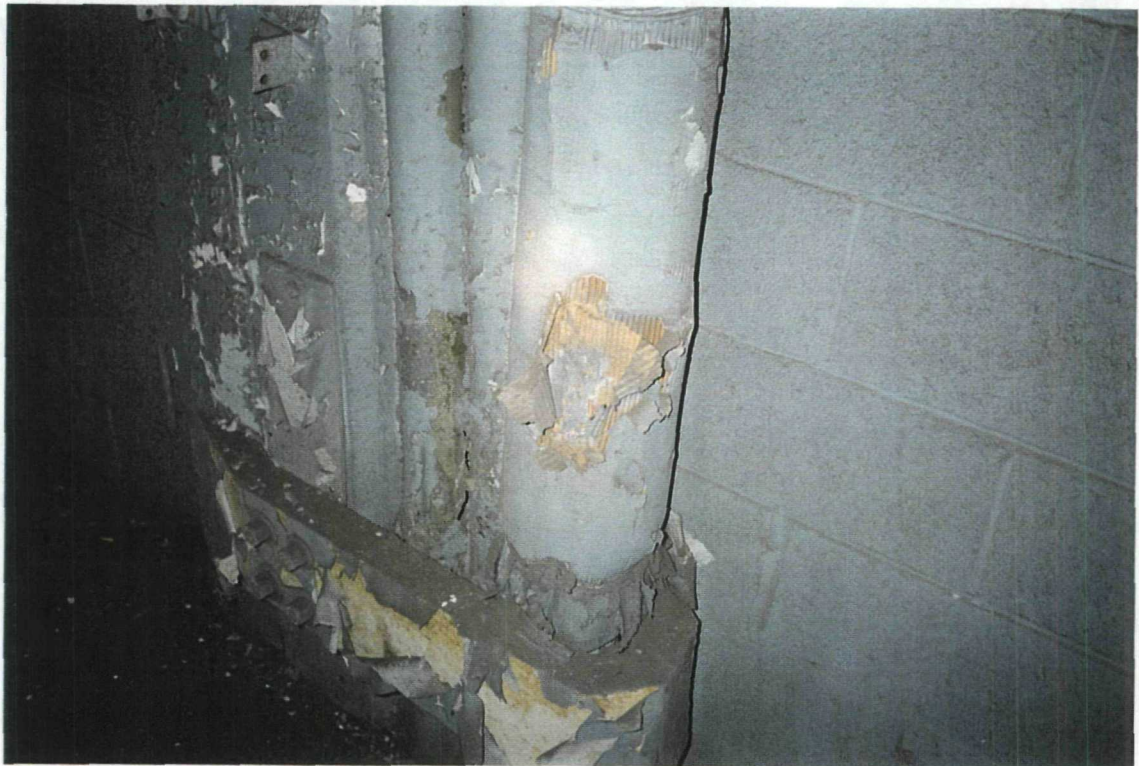
DESCRIPTION:  
Asbestos pipewrap (aircell) on horizontal pipe on second floor of Building 16/18.

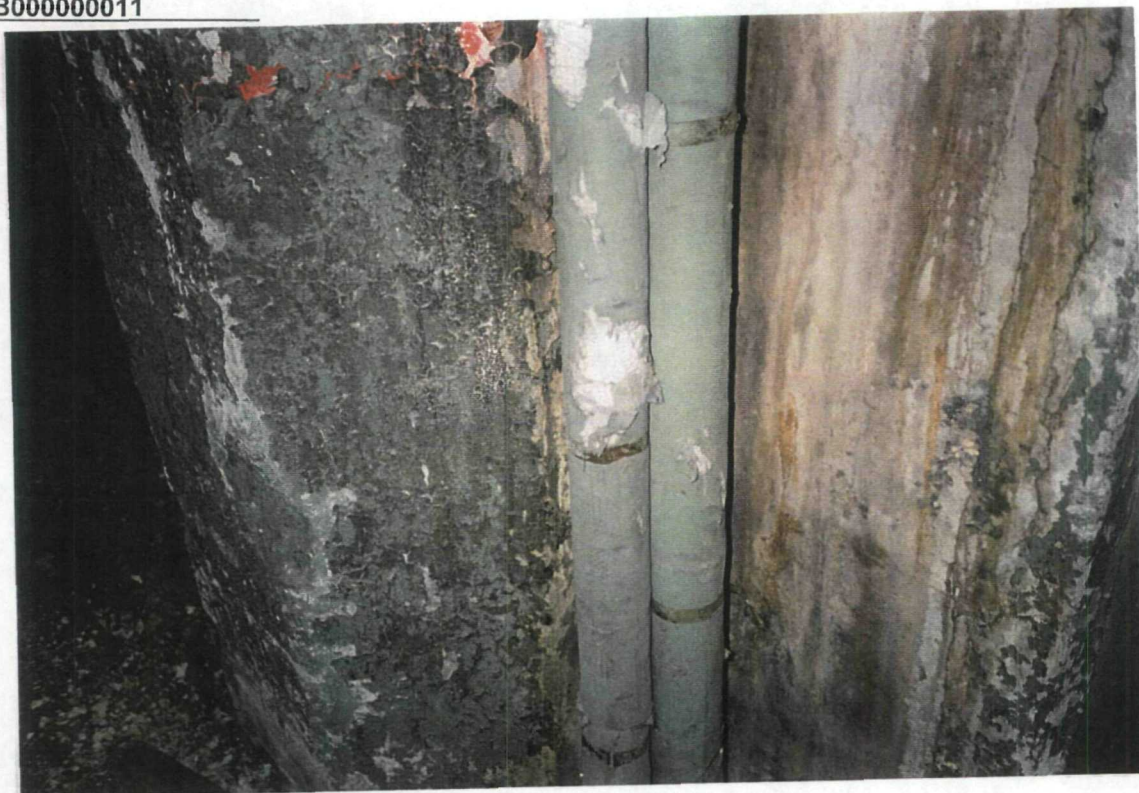
Asbestos pipewrap (aircell) on two vertical pipes in Building 2 and 2C.

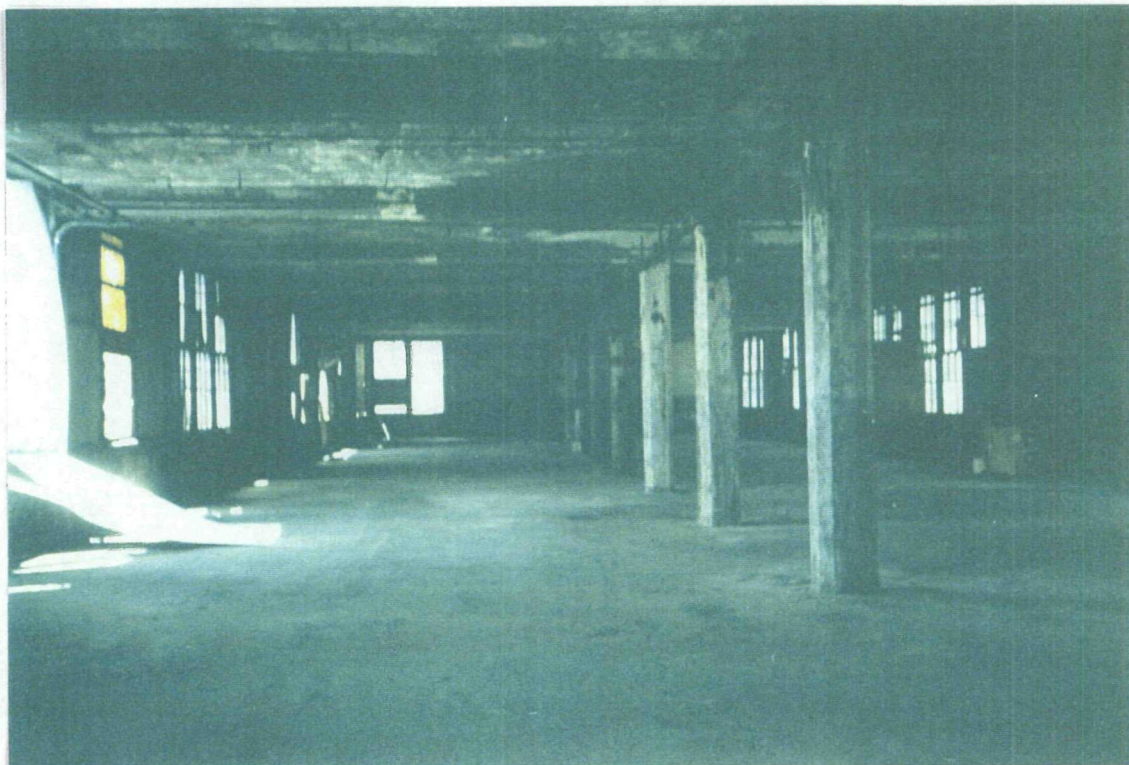
DESCRIPTION:  
Second Floor of Building 9/7/8, former plastics operation. North end of floor where evidence or previous fire noted.

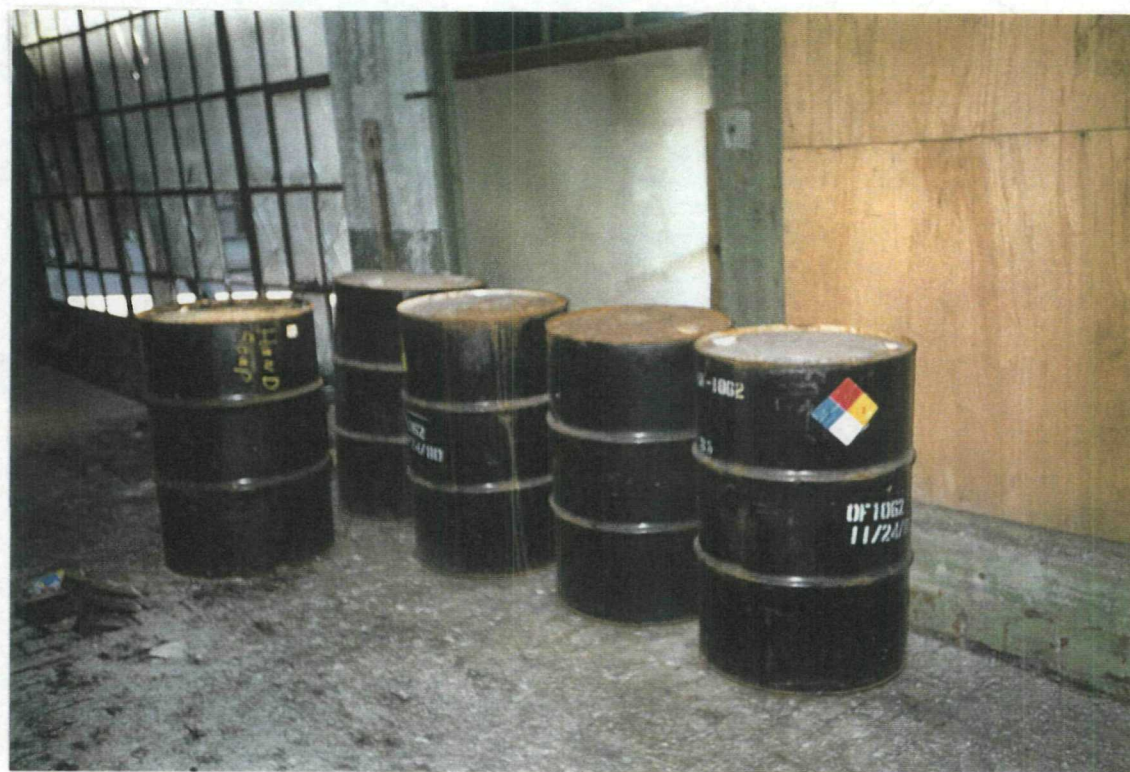
DESCRIPTION:  
Ground floor of Building 23, north end, 5 55 gallon metal drums.

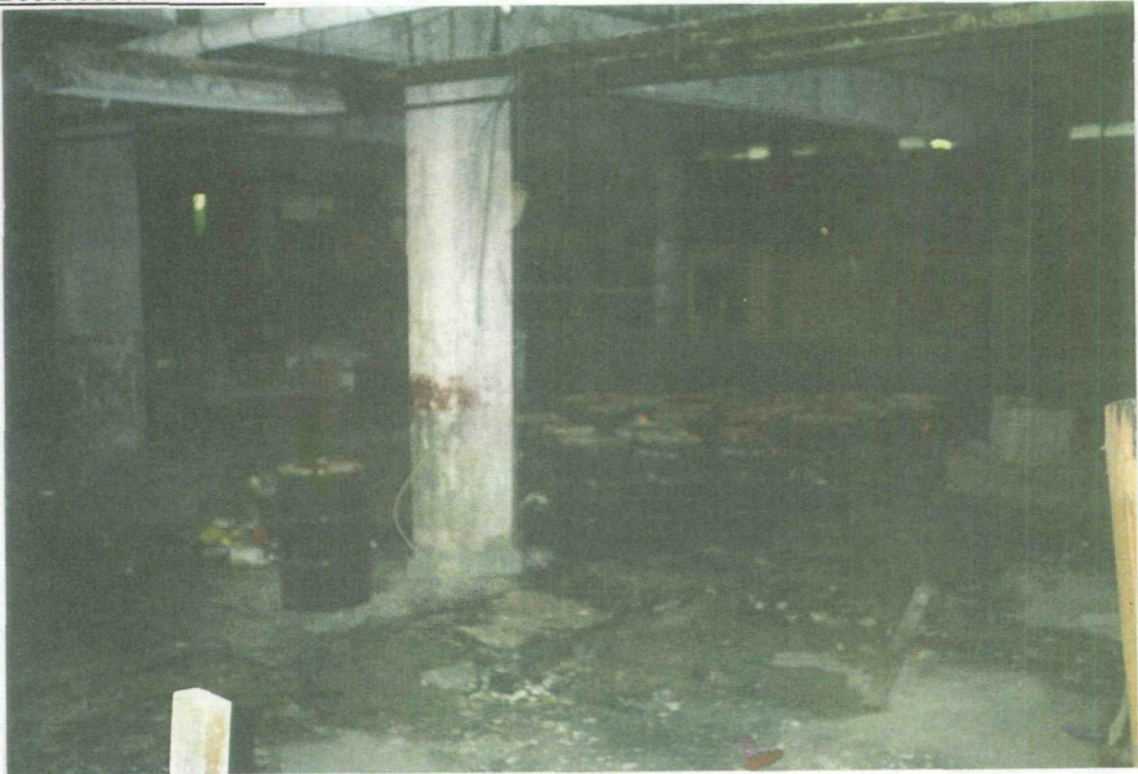
DESCRIPTION:  
First Floor of Building 23, north end, observed 26 55 gallon metal drums.

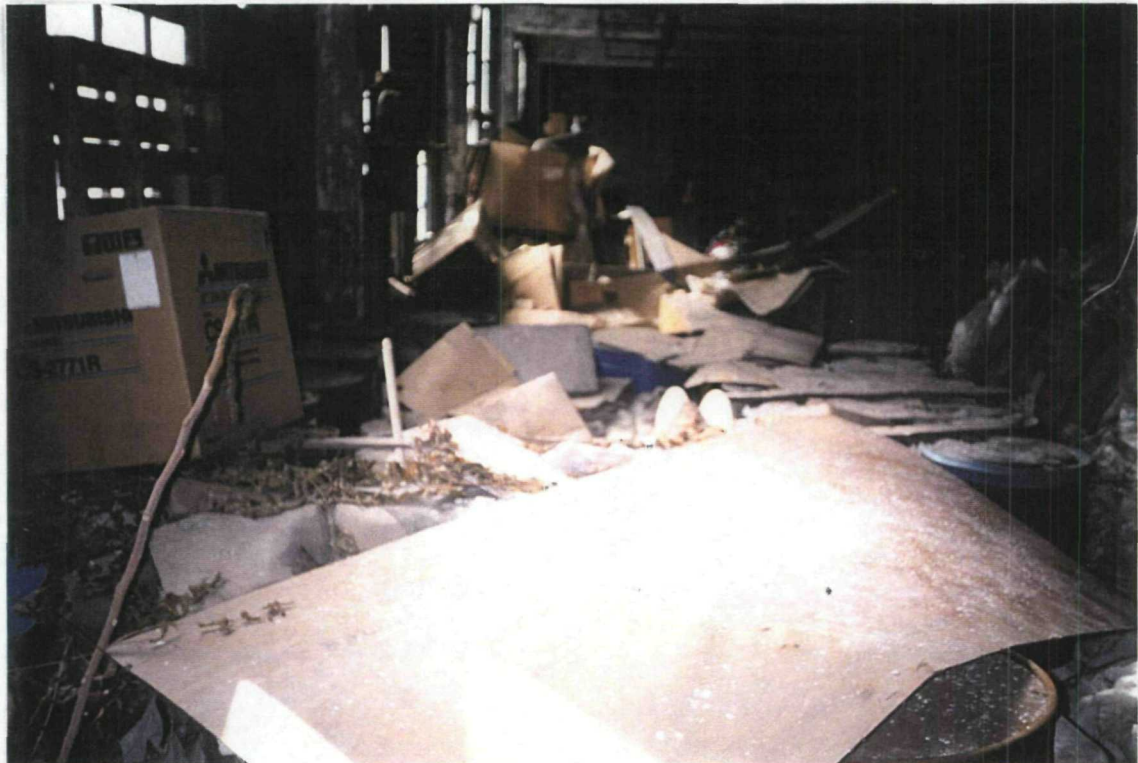
DESCRIPTION:  
First Floor of Building 23, south end, numerous 55 gallon drums under debris, both metal and plastic.

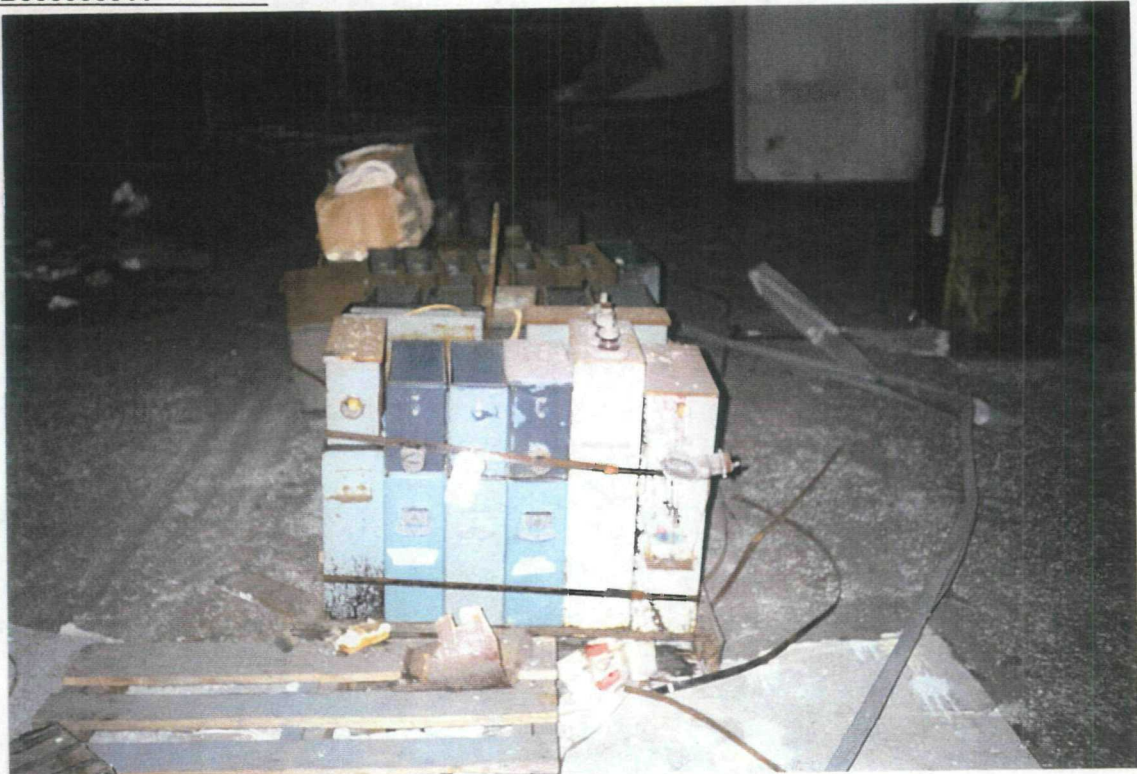
DESCRIPTION:  
Second Floor of Building 1, capacitor carcasses left by former tenant, Dyna Power.

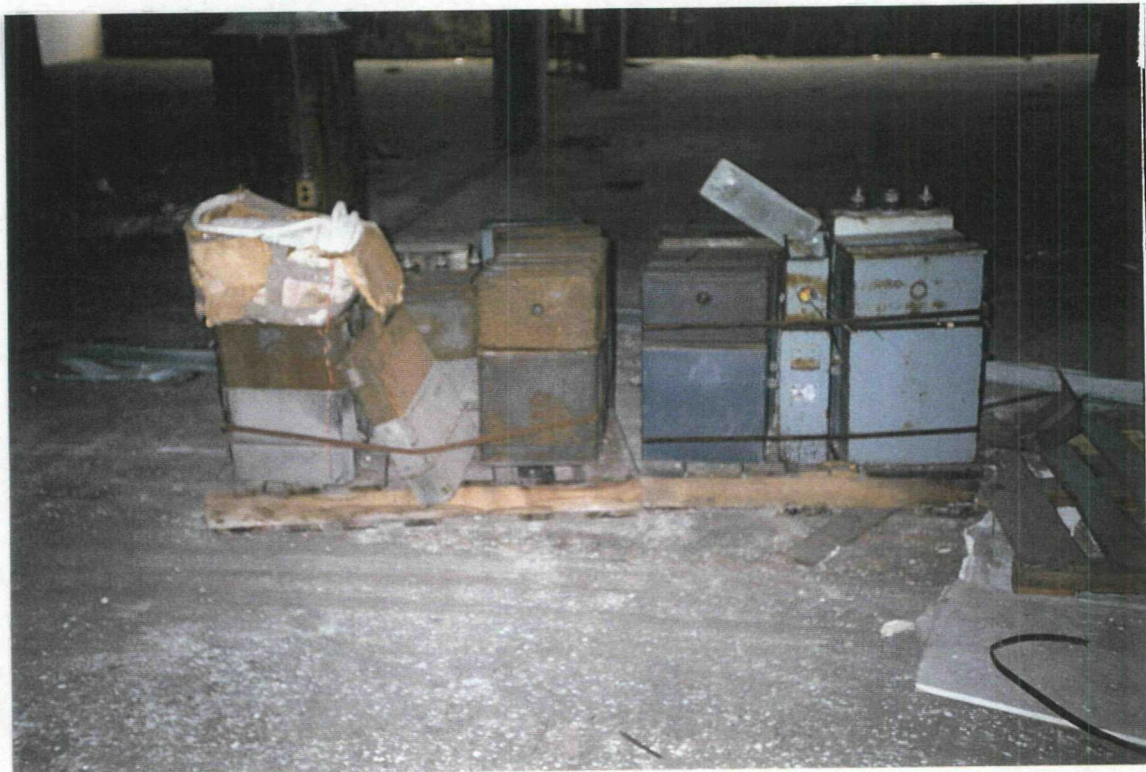
DESCRIPTION:  
Second Floor of Building 1, capacitor carcasses left by former tenant Dyna Power.

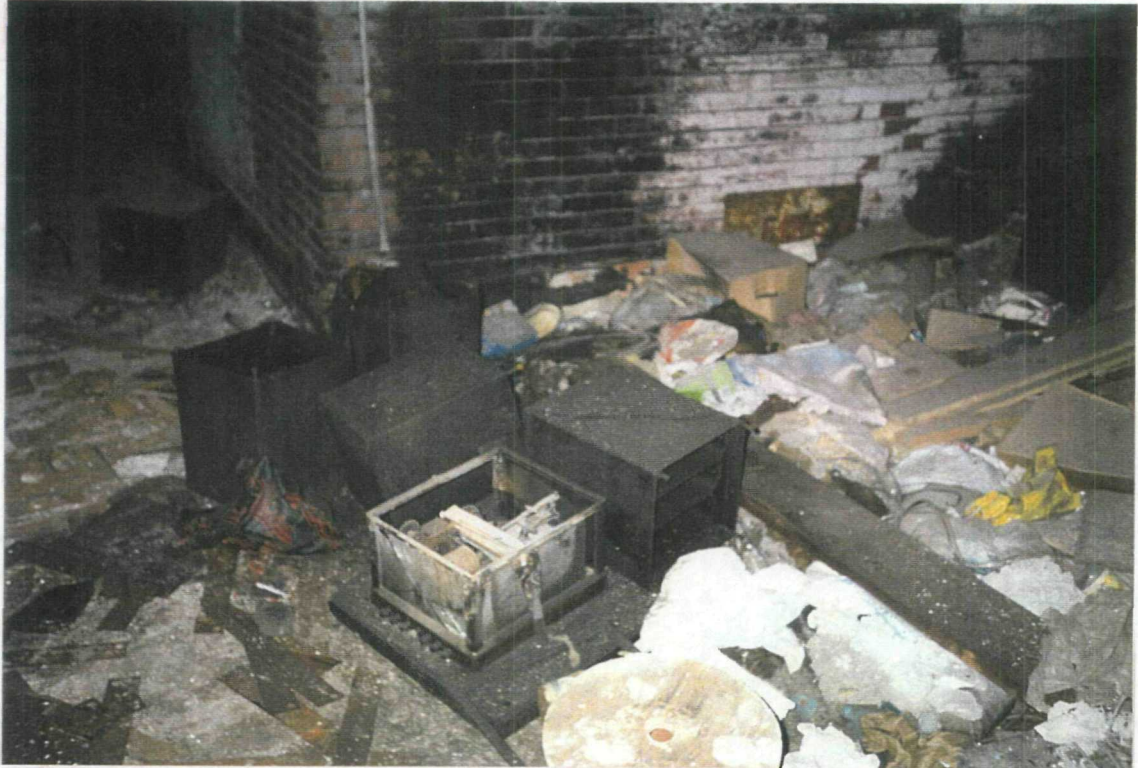
DESCRIPTION:  
Seven capacitor carcasses partially full of oil on second floor of Building 92. Capacitor fins scattered on floor.

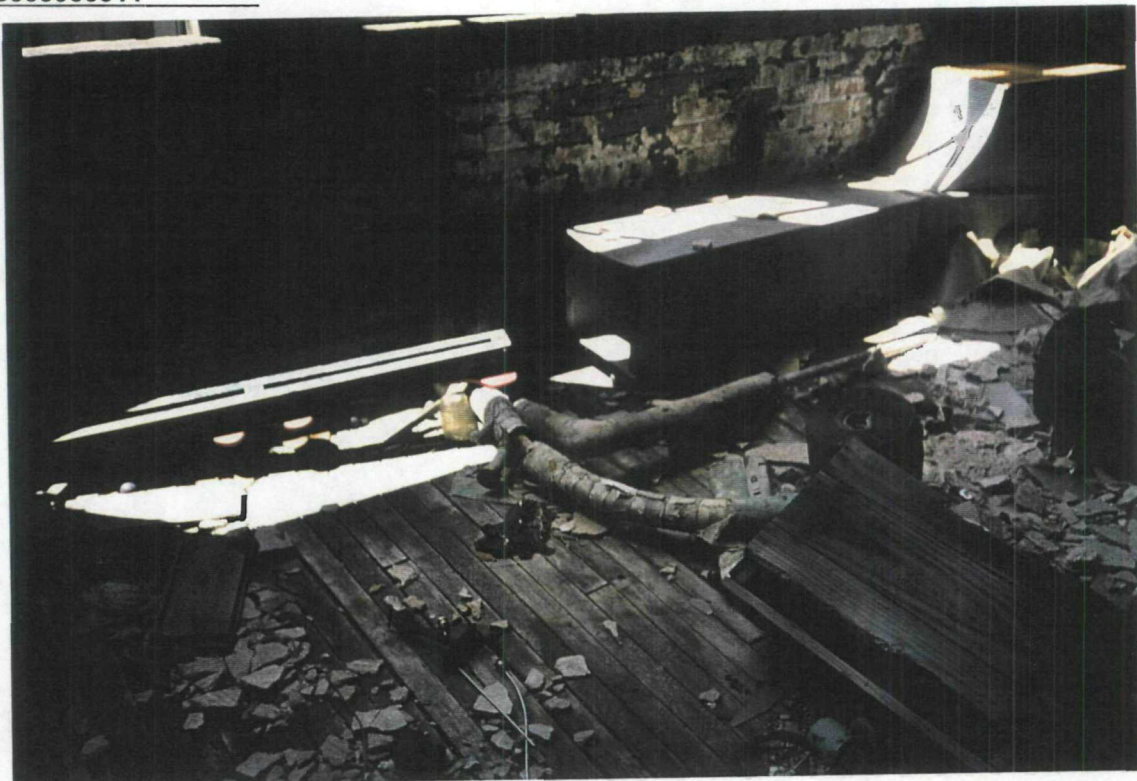
DESCRIPTION:  
Asbestos pipewrap (aircell) lying on fourth floor of Building 4.

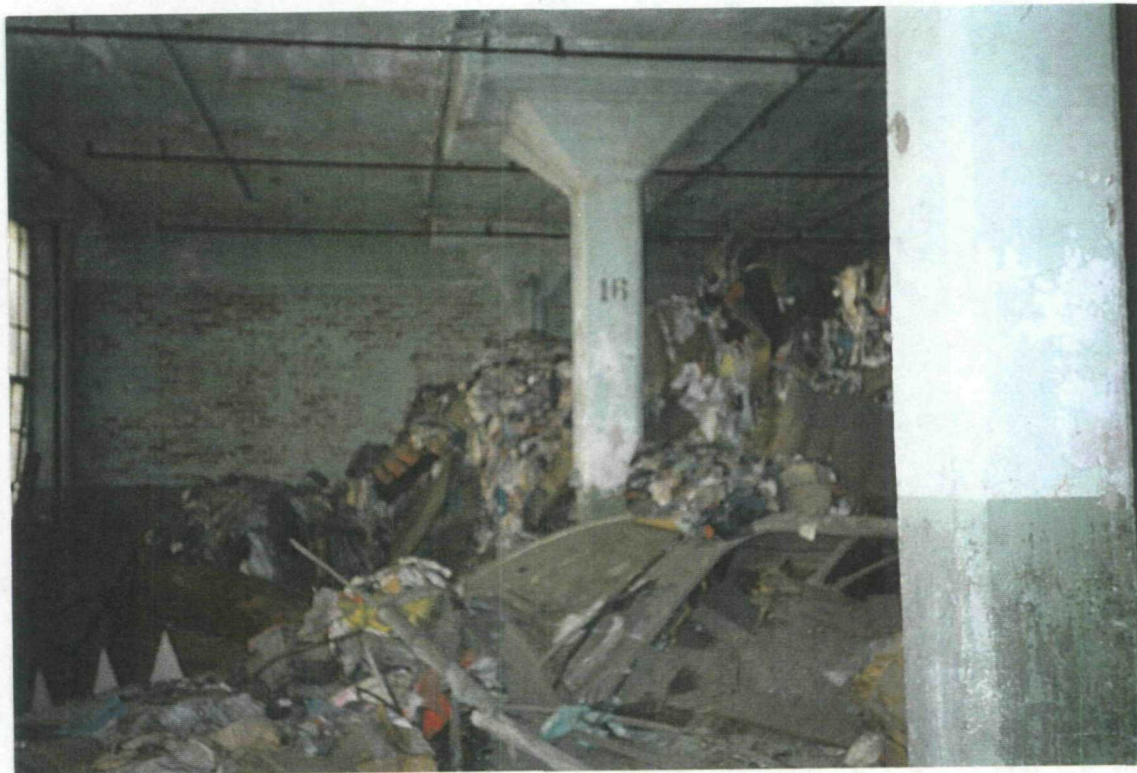
DESCRIPTION:  
Piled rags on Second Floor of Building 4.

- Removal of scattered debris including empty 55-gallon drums, 5-gallon buckets, wooden pallets, construction materials, old office furniture, tires, bundled rags, piled plastic pellets and other material noted during building audit walk through. These are located in Buildings 10,11,12, 1,5,4 and especially Building 23.

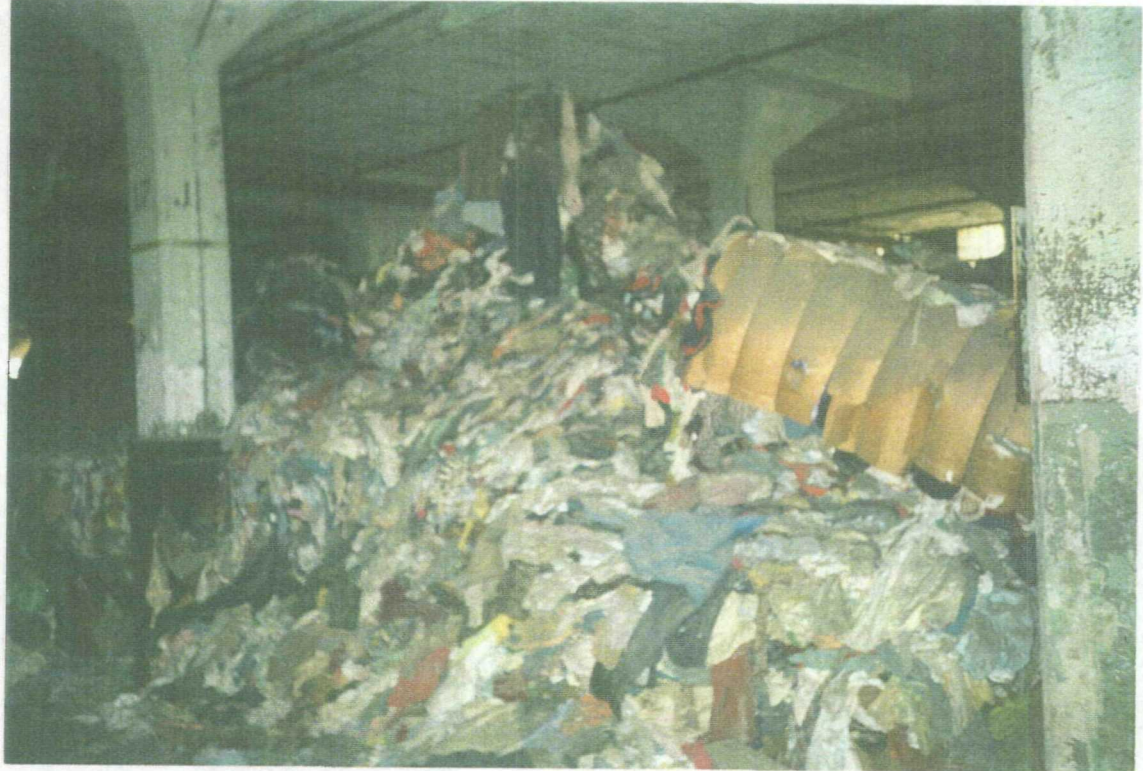
DESCRIPTION:  
Second Floor of Building 4, piled rags.

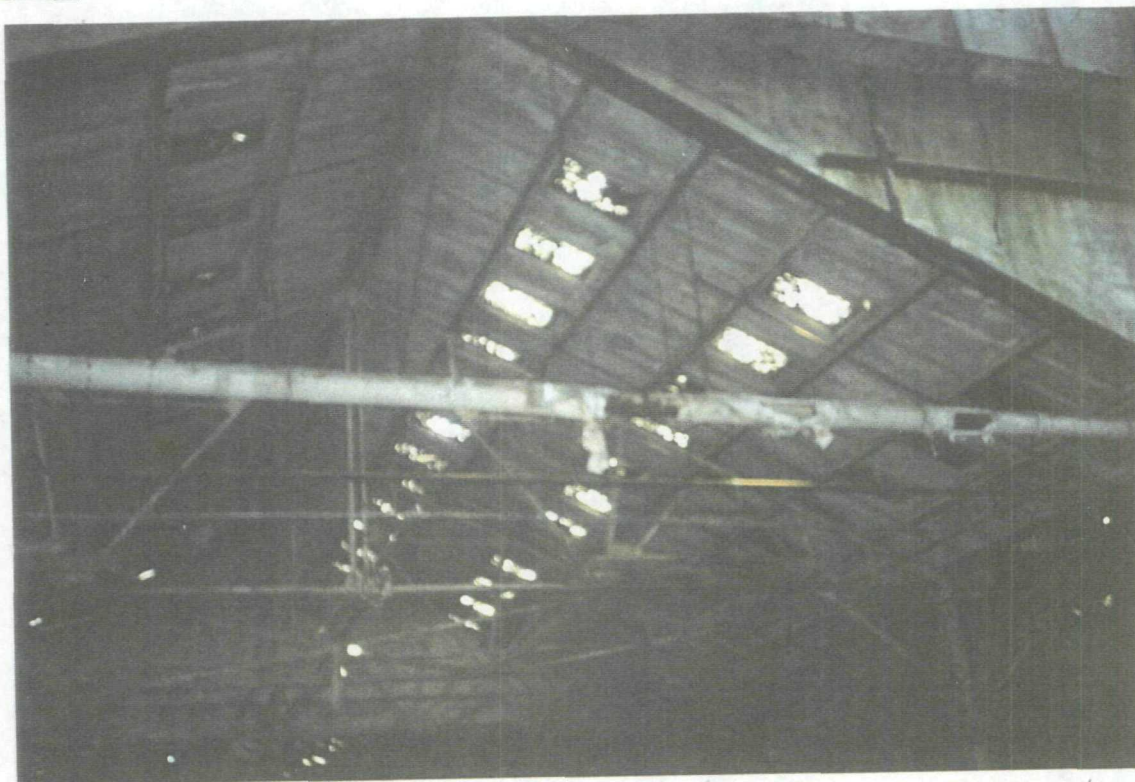
DESCRIPTION:  
Asbestos pipewrap (aircell) on ceiling pipes in First Floor of Building 90 and 91.

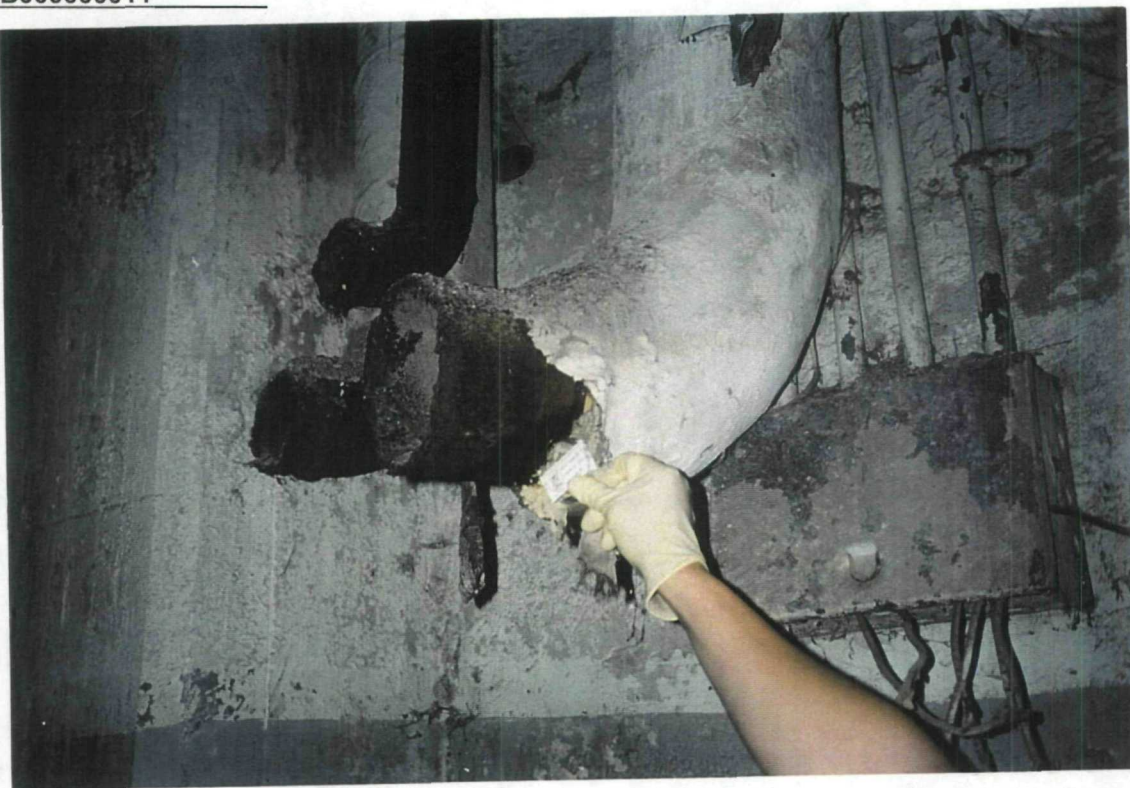
SAMPLE ID:  
HA001-01

Aircell pipe wrap collected from pipes along wall in the basement of Building 38.
